**IMPACT RESISTANCE OF  
COMPOSITE FAN BLADES**

**E. J. PREMONT  
K. R. STUBENRAUCH**

**PRATT & WHITNEY AIRCRAFT  
DIVISION OF UNITED AIRCRAFT CORPORATION**

**CONTRACT NAS3-16763**

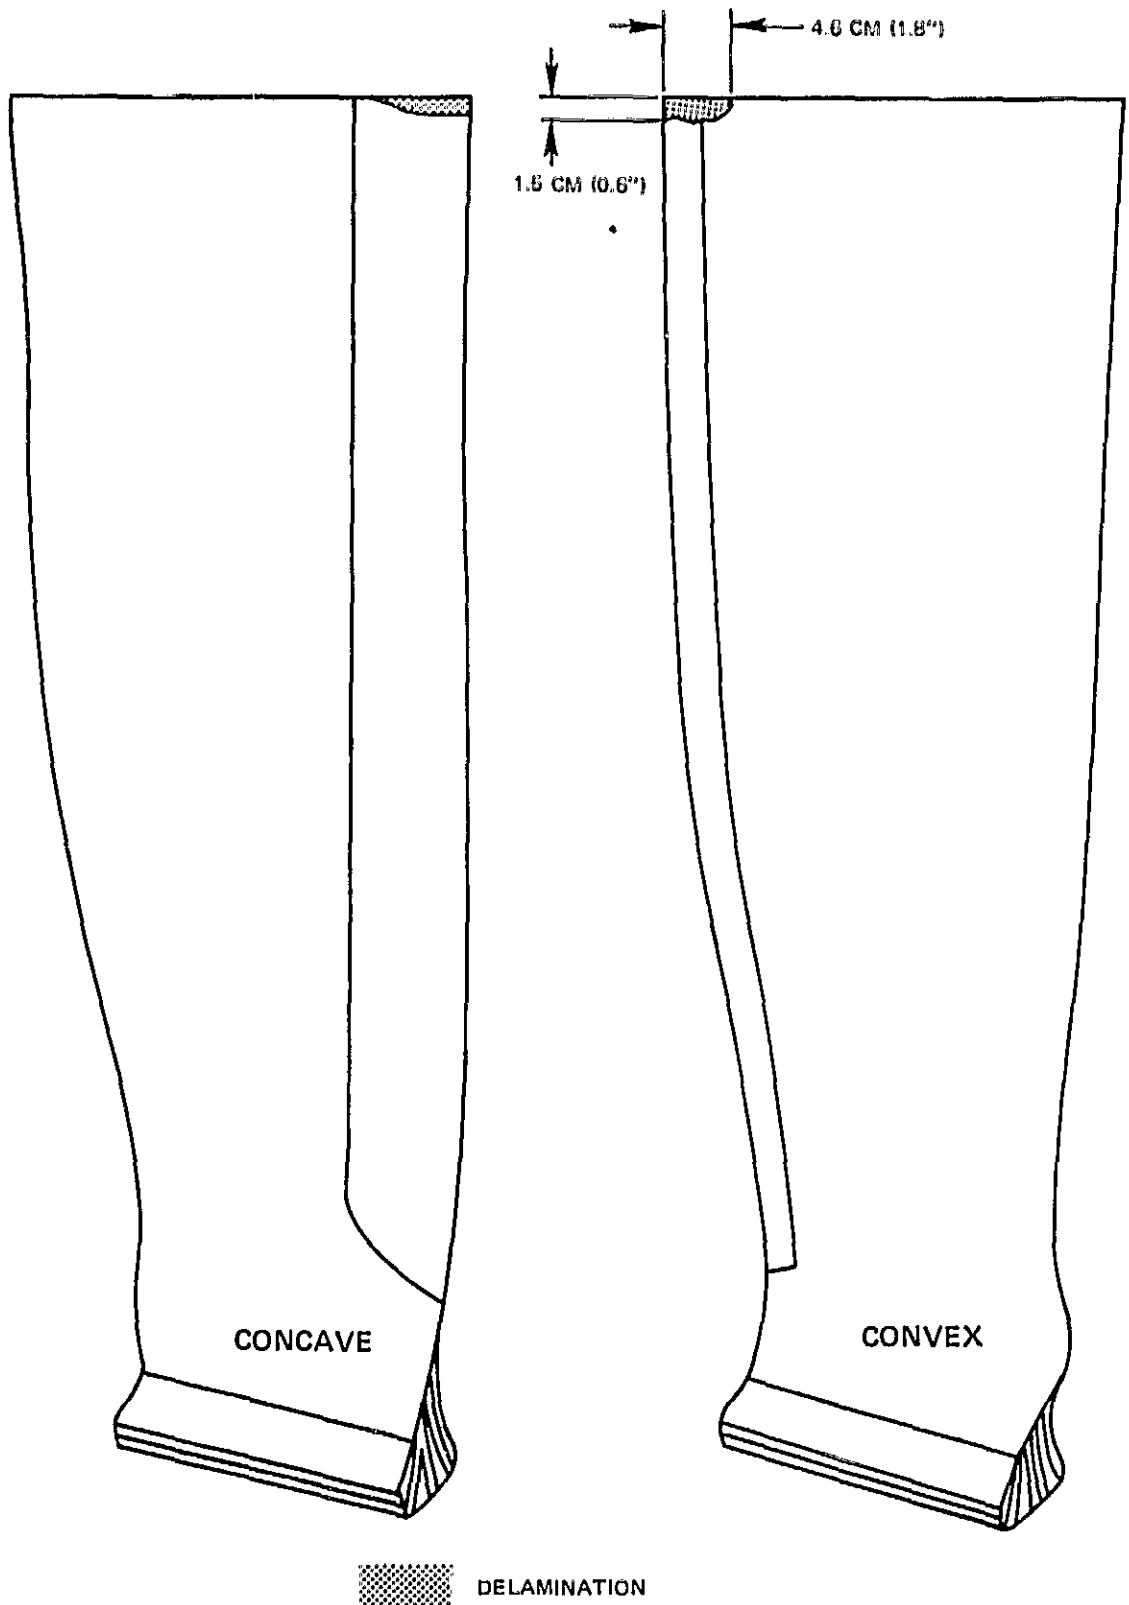
In the 5.1 cm (2.0 in) diameter ice ball impact tests of blades C-1 and B-1, the high speed movies showed that the ice ball shattered upon contact with the blade leading edge in each case. Visual damage to the two blades after impact with the 75g (2.6 oz) ice balls is shown schematically in Figures 23 and 24 and pictured in Figures 25 and 26. The small area of composite delamination on blade C-1 was in the area where ultrasonic indications of poor consolidation was found during pre-test NDI. This ultrasonic area grew during testing, as shown in Figure 27. The tip deflection caused by the impact tends to further loosen any existing delamination. Due to the designed thinness of the composite at the blade tip leading edge, the impact has an increased effect on this area.

Figure 23 Visual Damage to Graphite/Epoxy Blade C-1 Following Impact with Ice Ball

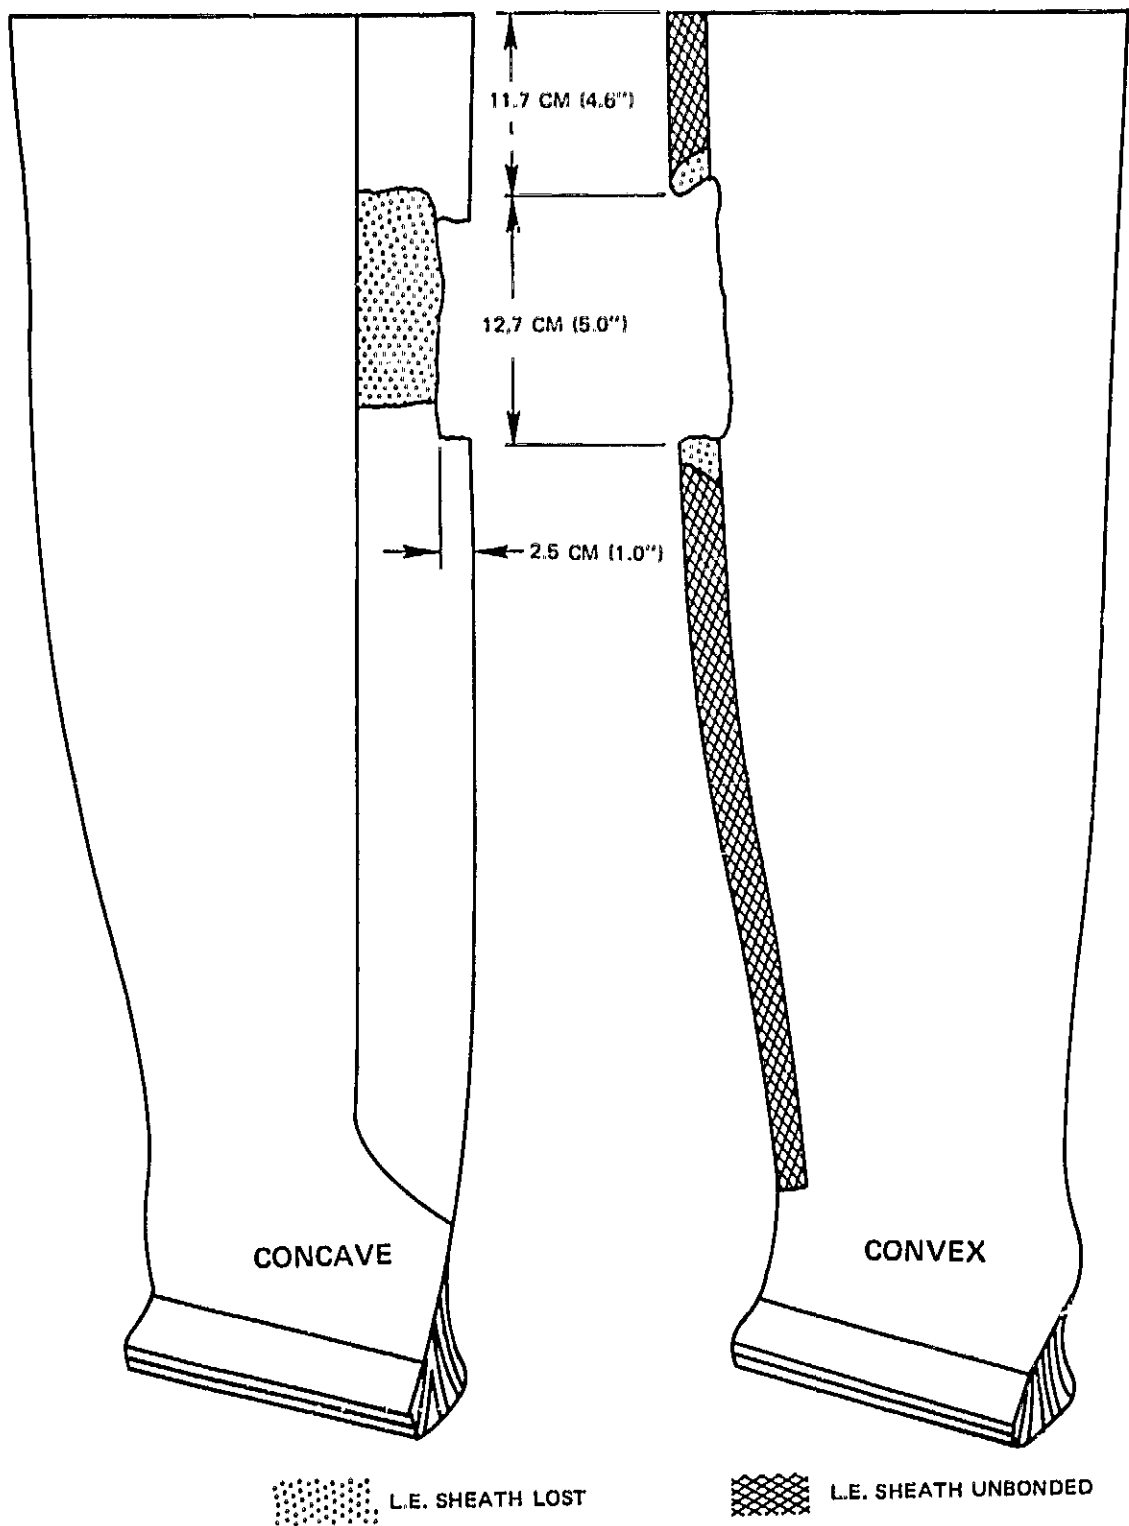
The damage to blade B-1 from the ice ball impact was more severe, however, no post-test ultrasonic indications were found. High speed movies show that blade B-1 took a large slice of the ice ball (approximately three-quarters of the ball), whereas blade C-1 hit the ice ball at its mid-point. This seems to be the only factor which affected the amount of damage sustained by each blade. The difference in FOD was not expected due to the composite material differences. The FOD threshold is very likely close to the ice ball weight of 75g (2.6 oz).

Figure 24 Visual Damage to Boron/Epoxy Blade B-1 Following Impact with Ice Ball

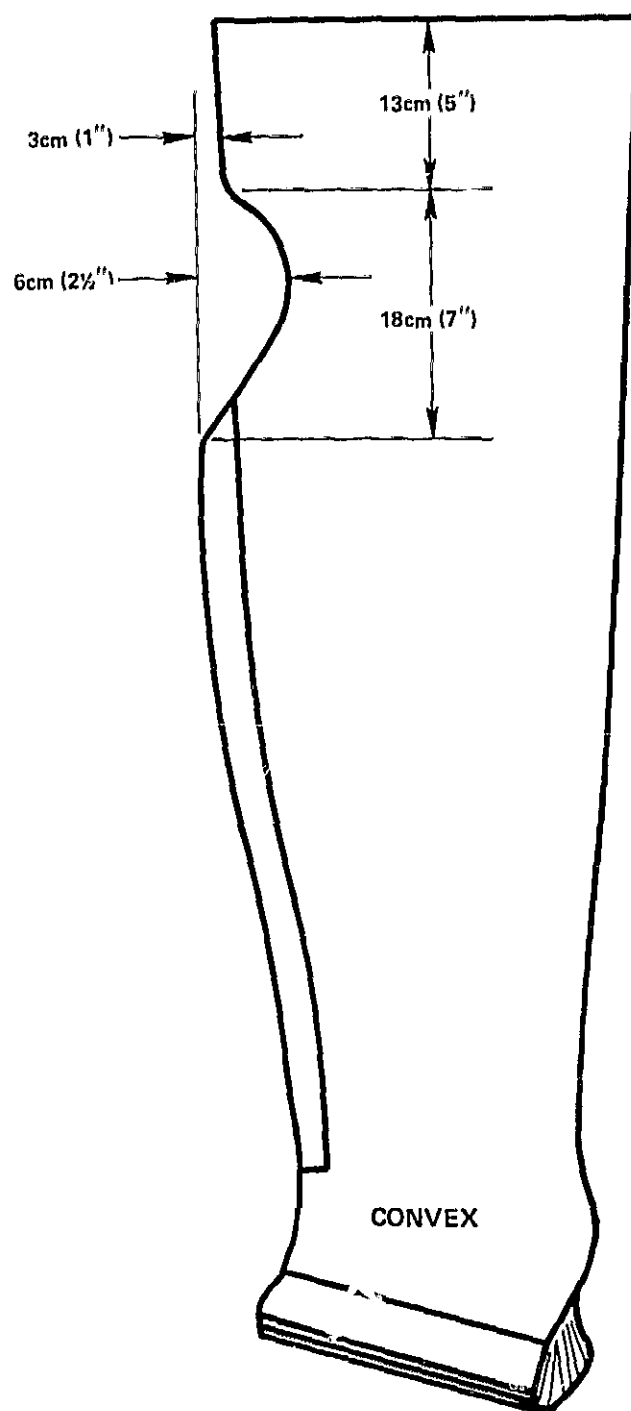
The 320g (11.2 oz) gelatin ball impact caused damage to graphite/epoxy blade C-2 as sketched in Figure 29 estimated from the final sequence photo of Figure 28. The high-speed movies revealed that the slice size for this first impact was approximately 110g (3.8 oz). In this test, the object catching system failed to prevent a second impact. The remaining 210g (7.4 oz) piece of gelatin ball hit the blade inboard of Section K-K where the airfoil chord angle is greater. The damage from both impacts is sketched in Figure 30 and pictured in Figure 31. Post-test ultrasonic indications correspond to the delaminated area shown in Figure 30.

Figure 29 Estimated Damage to Graphite/Epoxy Blade C-2 Following the First Impact with 320g Gelatin Ball

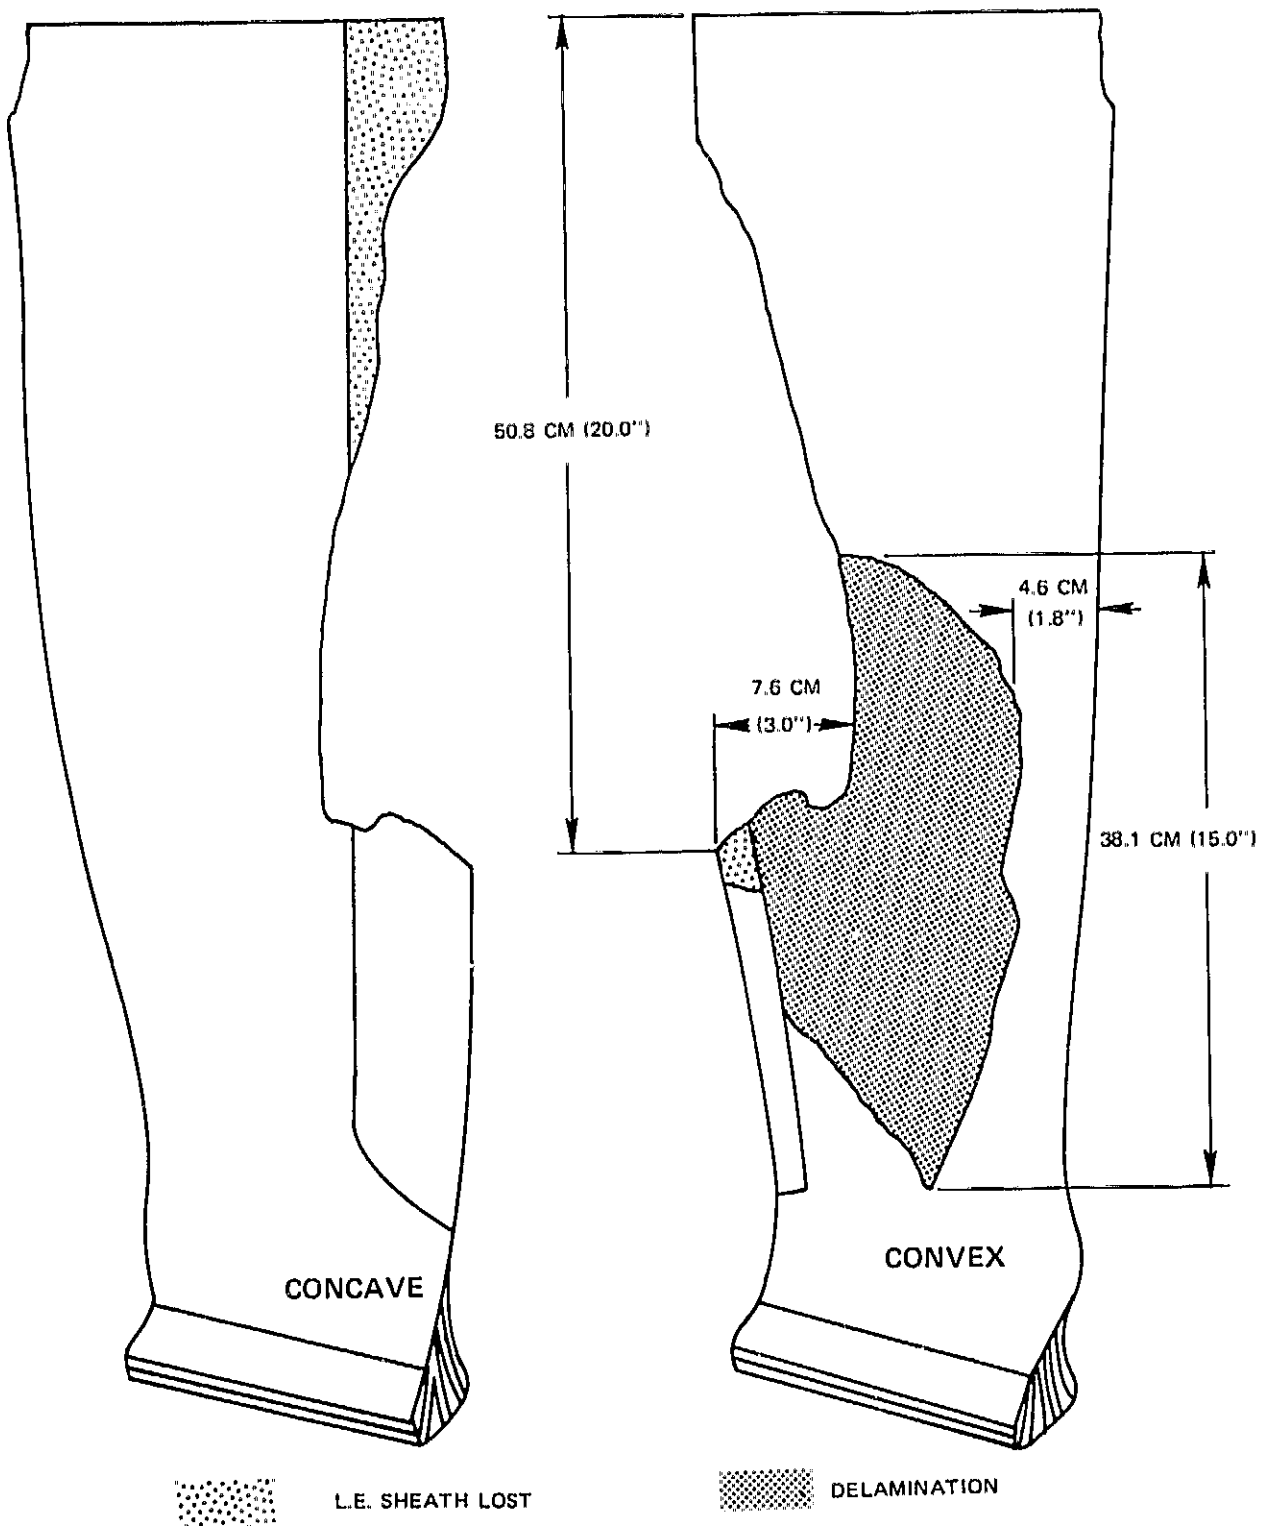
Figure 30 Visual Damage to Graphite/Epoxy Blade C-2 Following Two Impacts with 320g Gelatin Ball

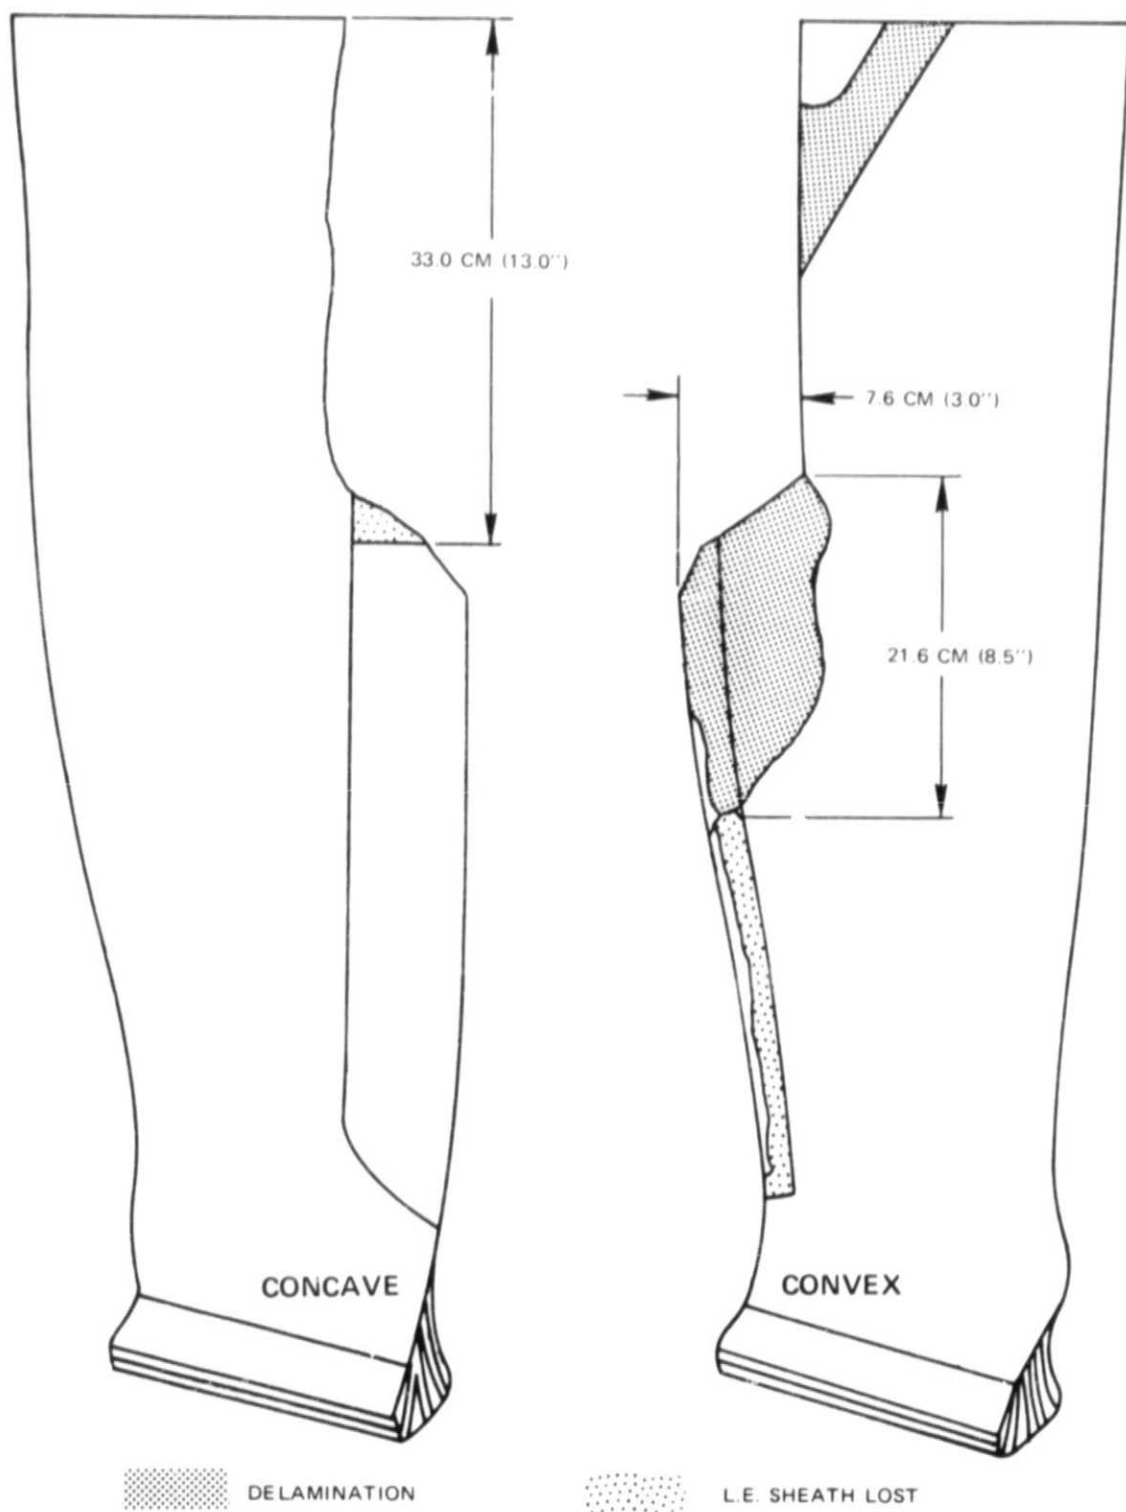
Blade C-3 sliced 105g (3.7 oz) from the 165g (5.8 oz) gelatin ball which impacted the blade leading edge at Section K-K. Visual damage is shown in Figures 32 and 33. Ultrasonic indications after testing were in the areas labeled as delamination in Figure 32.

Figure 32 Visual Damage to Graphite/Epoxy Blade C-3 Following Impact with 165g Gelatin Ball

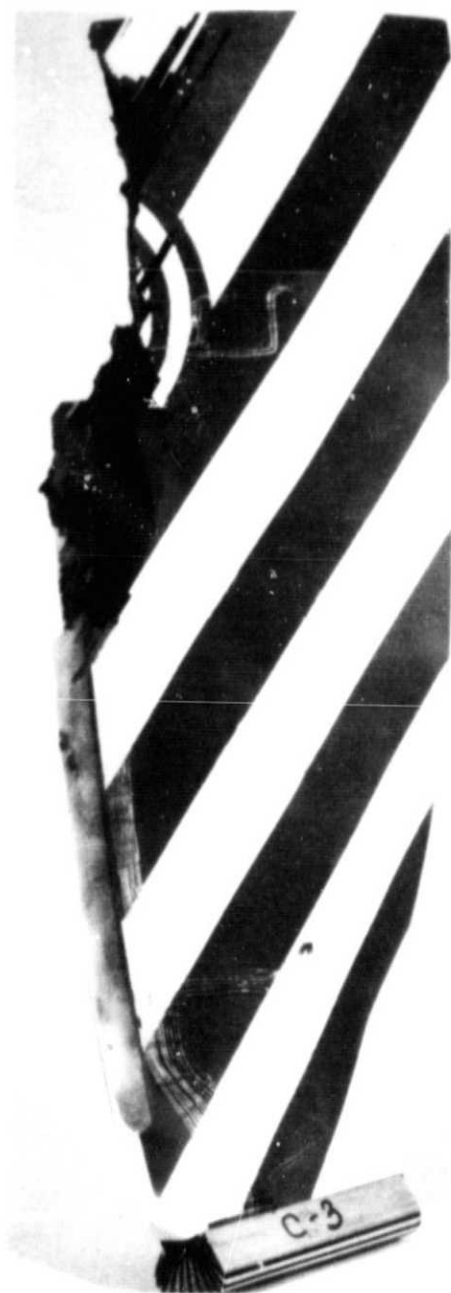
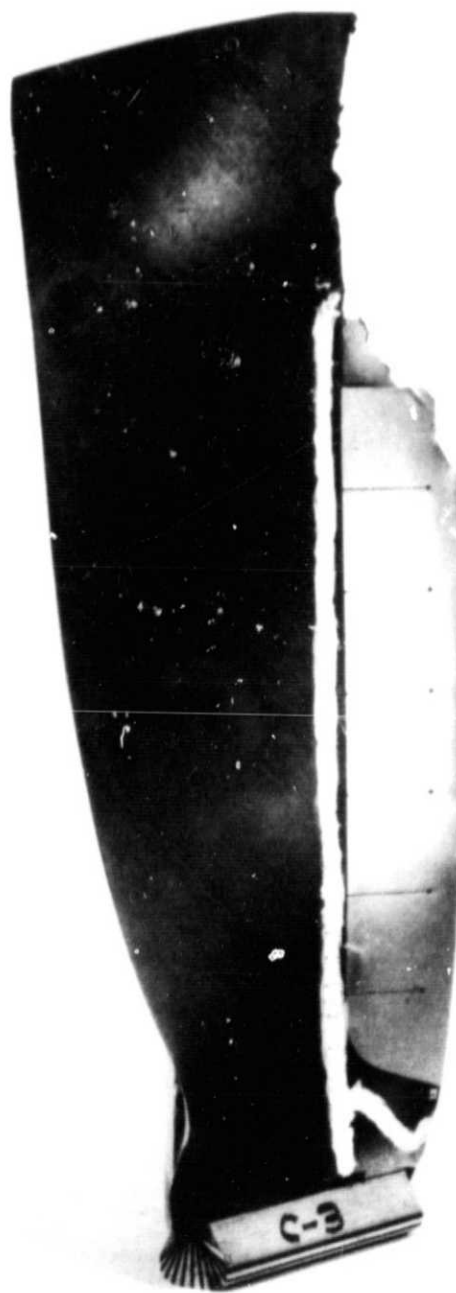
Figure 33 Graphite/Epoxy Blade C-3 Following Impact with 165g Gelatin Ball

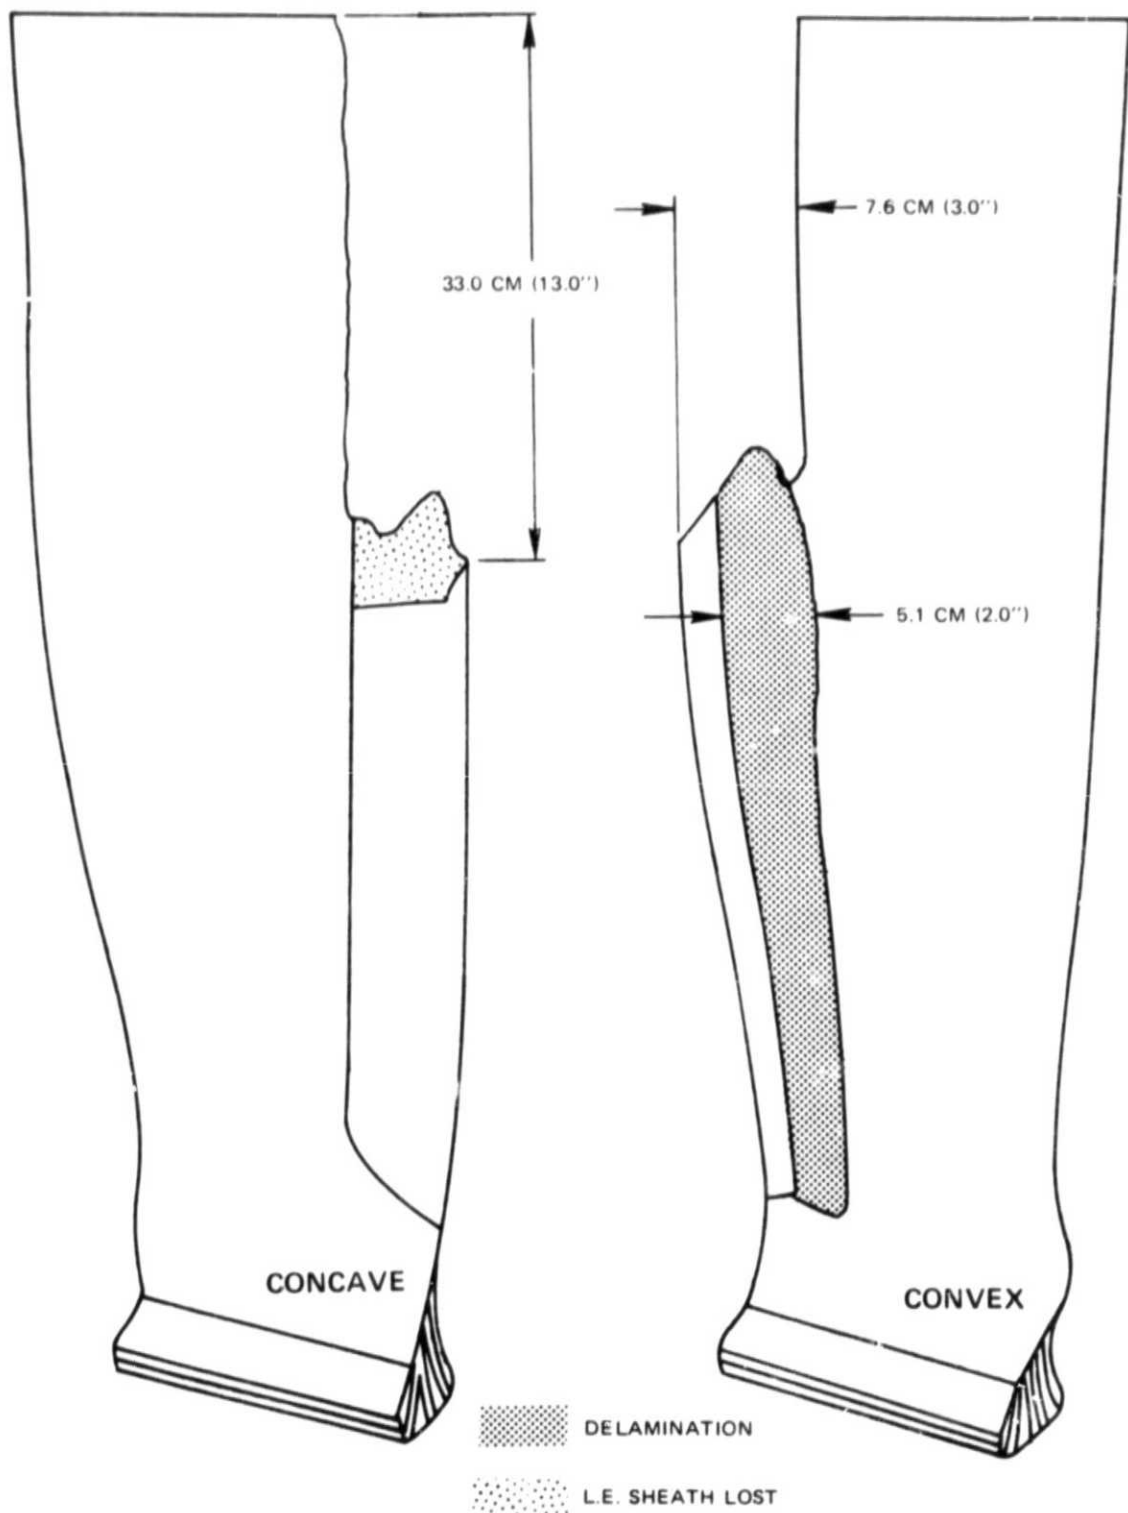
In the test of boron/epoxy blade B-2, a slice greater than one-half of the 320 g (11.2 oz) gelatin ball was taken. The 210g (7.4 oz) slice impact caused the damage shown in Figures 34 and 35. No ultrasonic indications were found on blade B-2 following testing.

Figure 34 Visual Damage to Boron/Epoxy Blade B-2 Following Impact with 320g Gelatin Ball

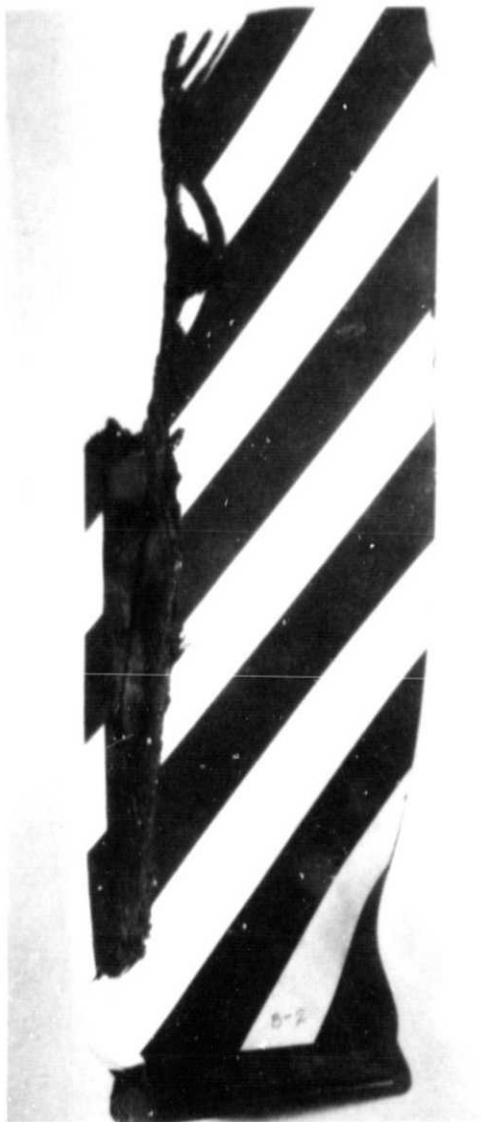
Figure 35 Boron/Epoxy Blade B-2 Following Impact with 320g Gelatin Ball

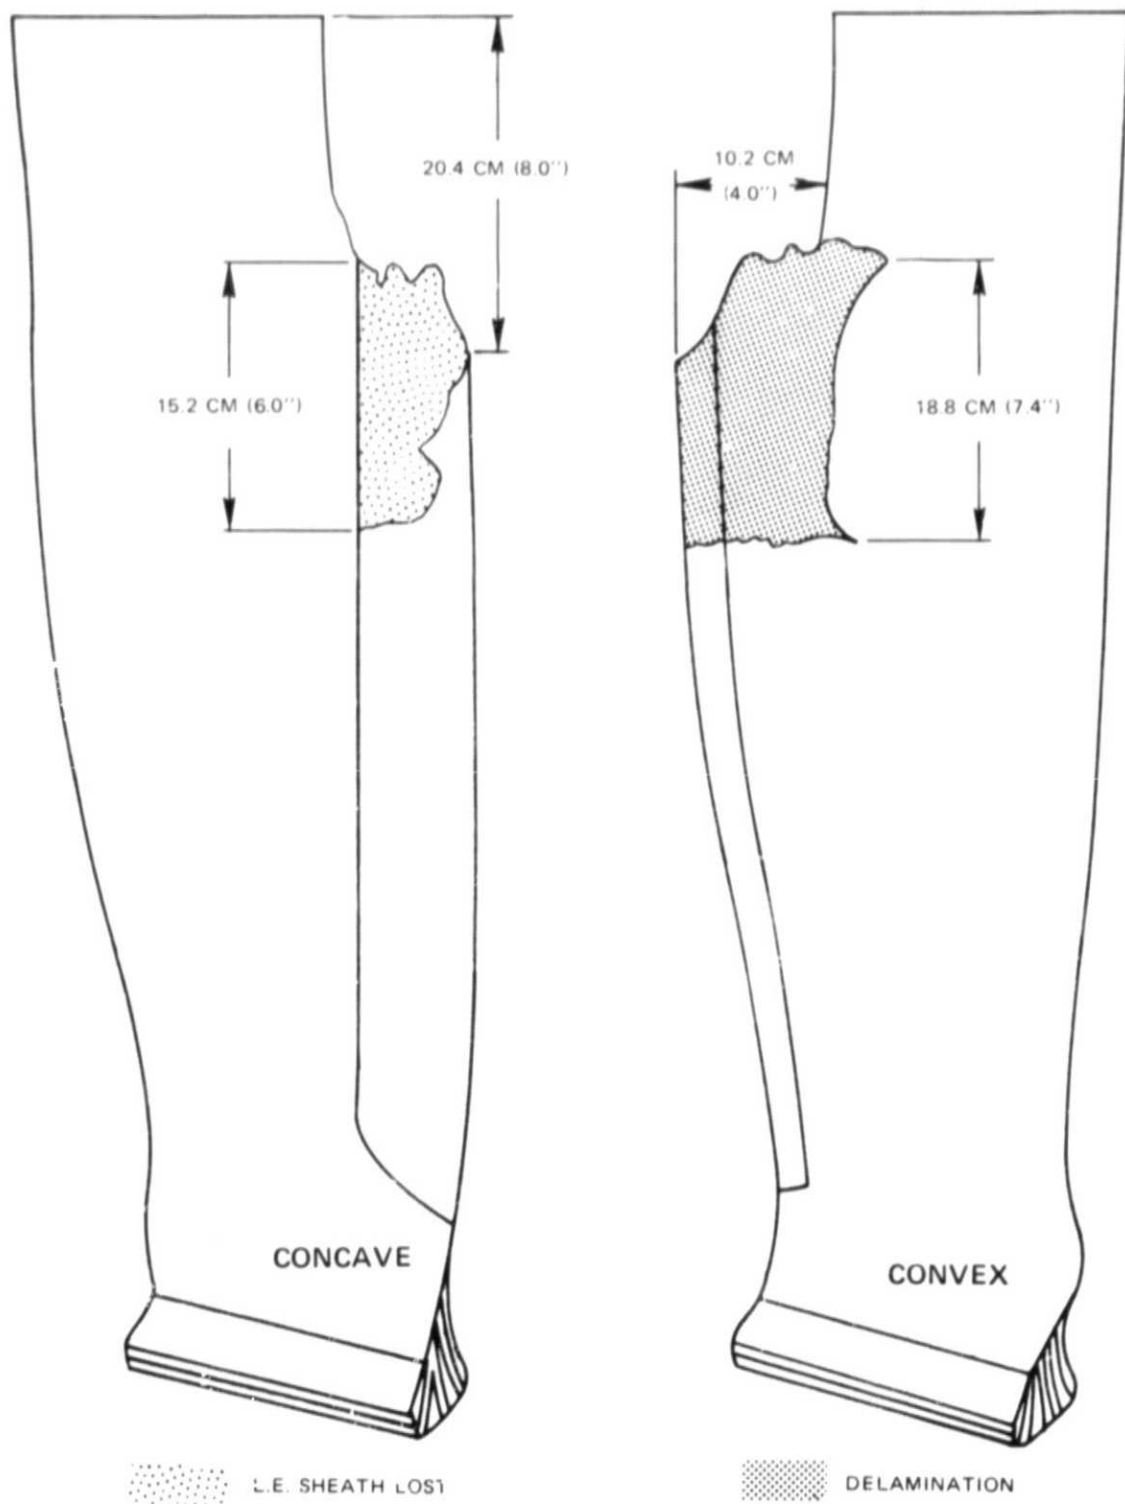
Boron/epoxy blade B-3 was impacted with a 165 g (5.8 oz) gelatin ball, however, a malfunction in the drop mechanism caused only a 25g (.9 oz) slice to be taken. The blade was visually and ultrasonically inspected following this impact and found to be undamaged. Blade B-3 was then retested with a new 165g gelatin ball. A 130g (4.6 oz) slice was cut from this ball and blade damage did occur as shown in Figures 36 and 37. Post-test ultrasonic indications correspond to the area shown as delaminated in Figure 36.

Figure 36 Visual Damage to Boron/Epoxy Blade B-3 Following Impact with 165g Gelatin Ball

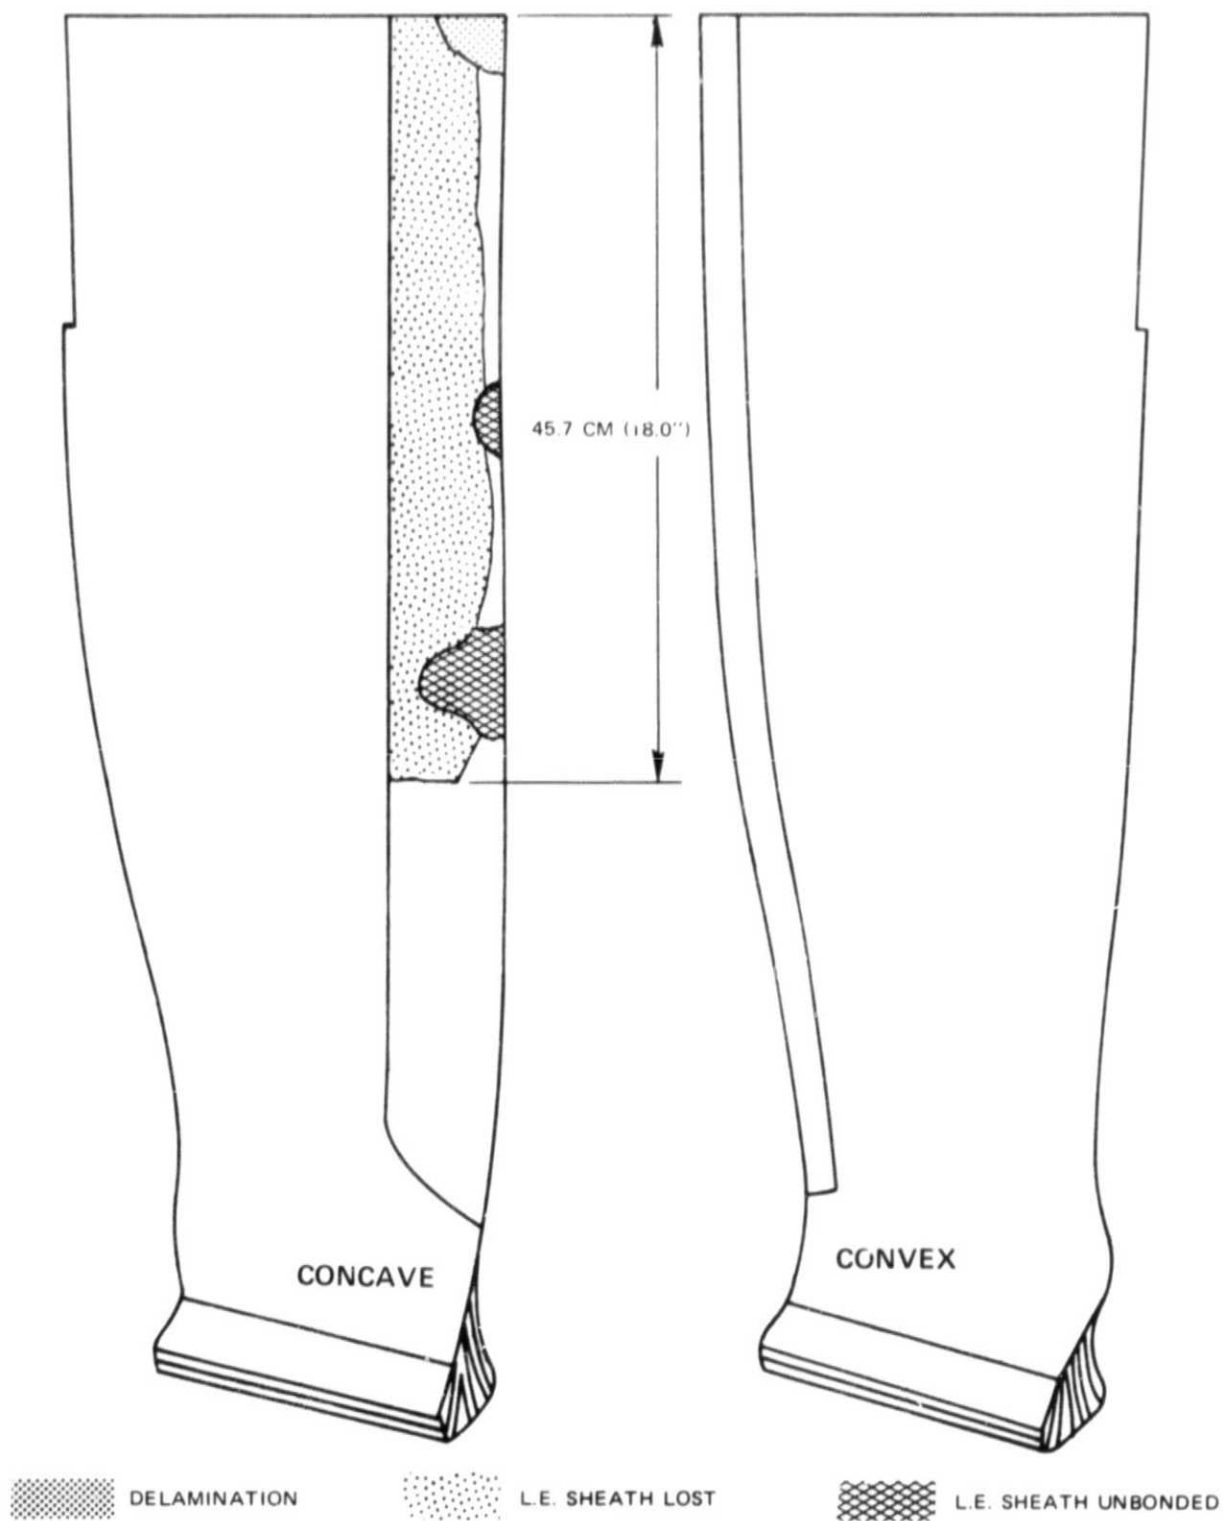
Blade C-4 and B-4 were each impacted with 30g (1.1 oz) of gravel. The leading edge sheath on the concave side of C-4 came off the blade as shown in Figures 44 and 45. This failure indicates the possibility of a poor bond between the blade and sheath, although pre-test NDI showed no lack of bonding. Post-test ultrasonic inspection showed indications in the two areas illustrated in Figure 46.

Figure 44 Visual Damage to Graphite/Epoxy Blade C-4 Following Impact with Gravel

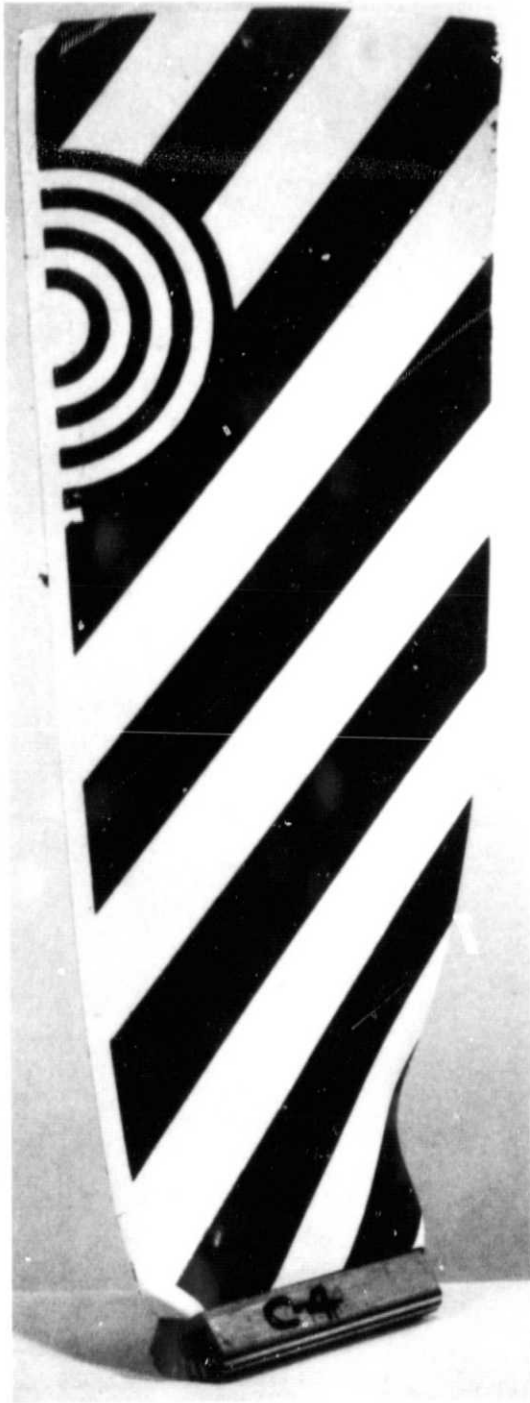
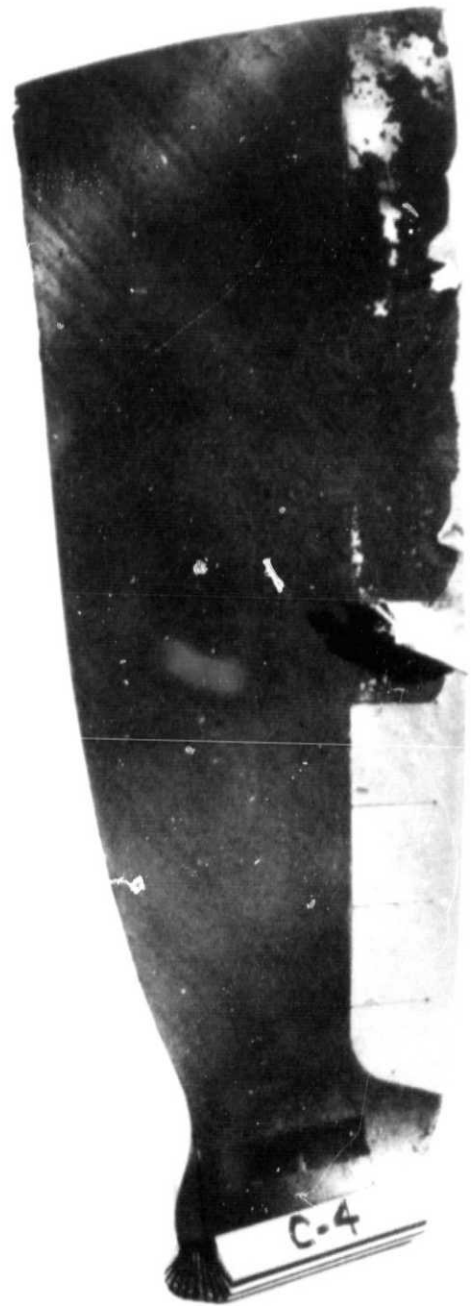
Figure 45 Graphite/Epoxy Blade C-4 Following Impact with Gravel

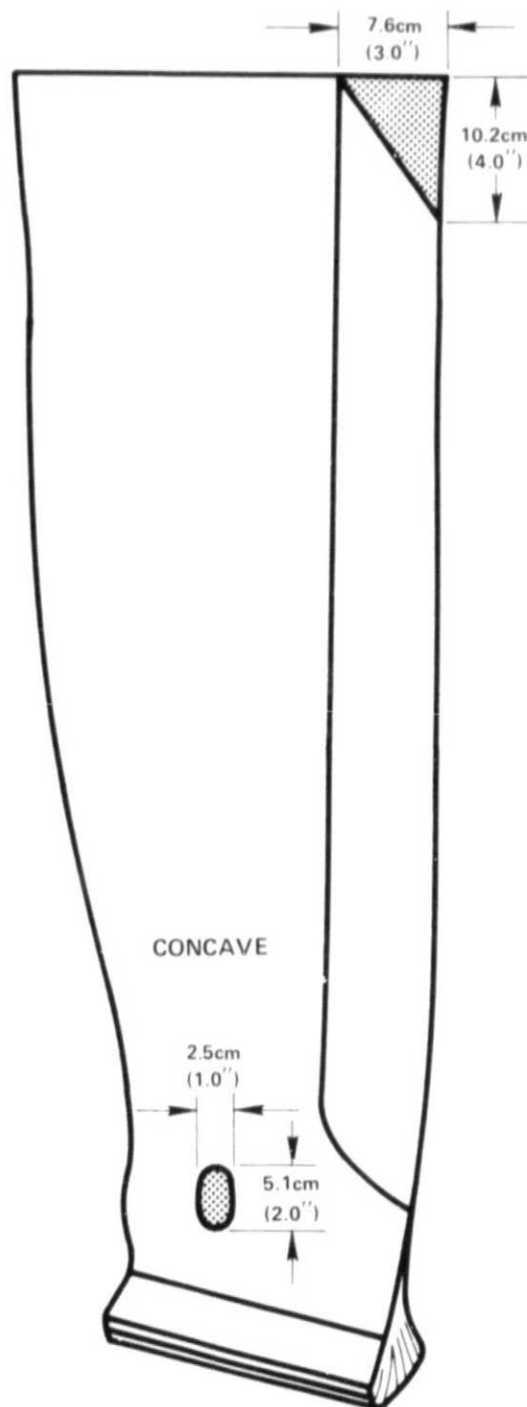
Figure 46 Post Test Ultrasonic Indications on Graphite/Epoxy Blade C-4

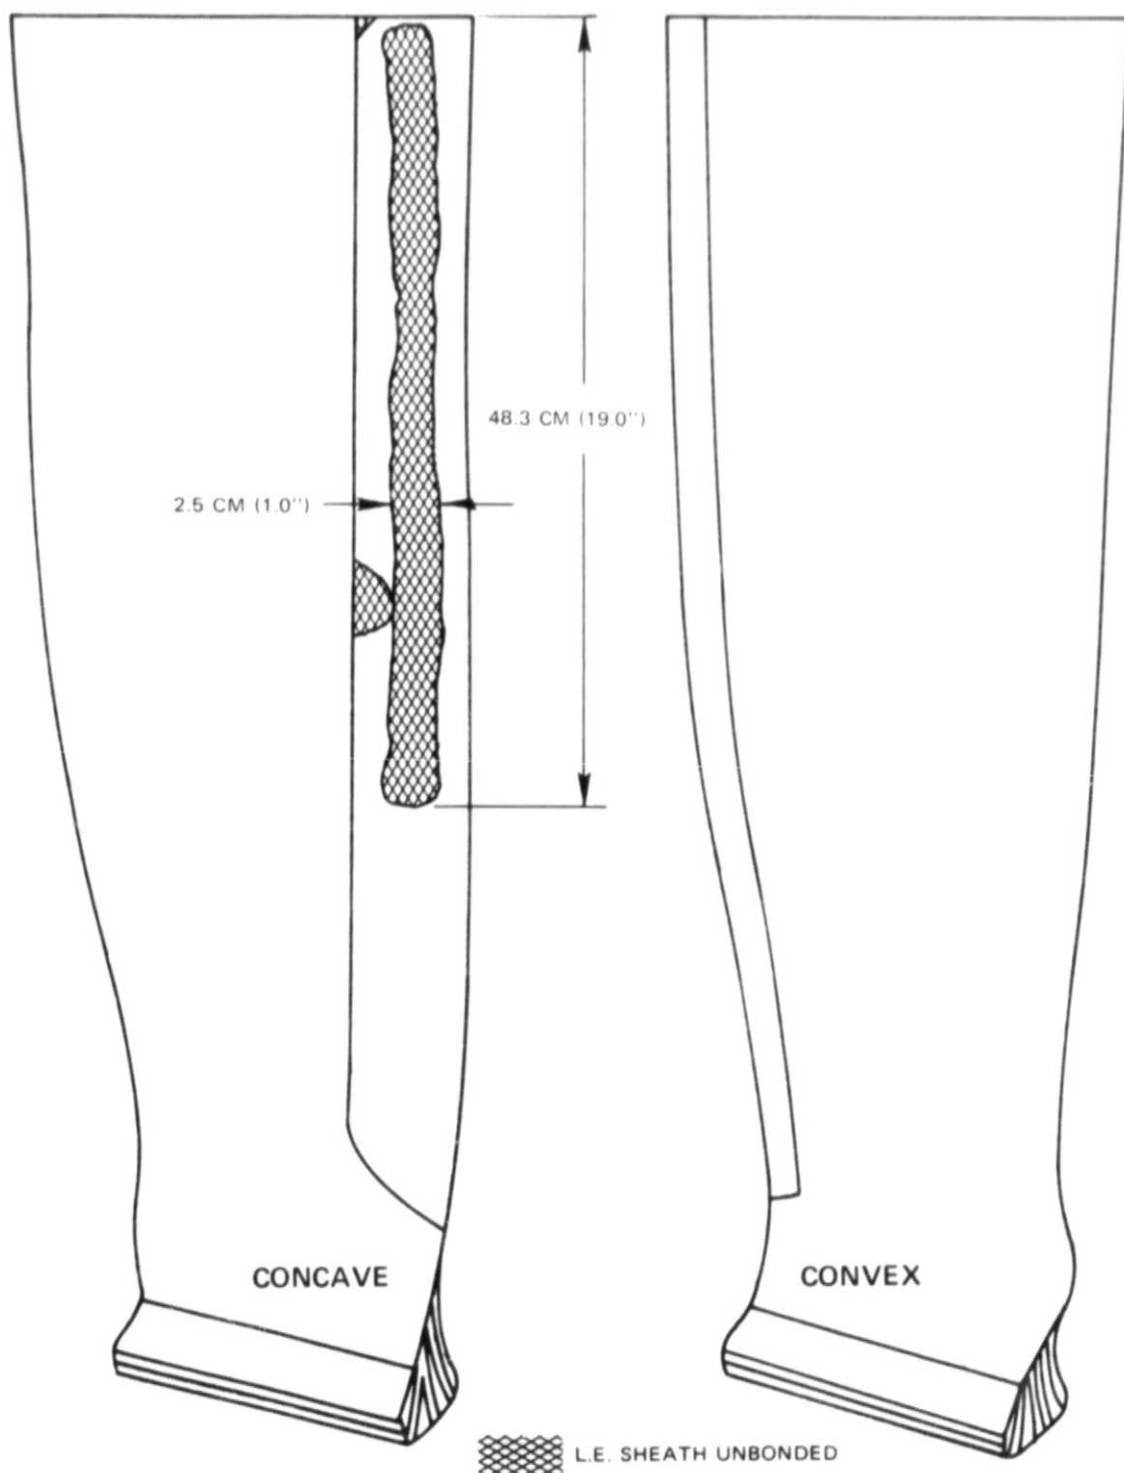
The gravel impact results on blade B-4 are shown in Figures 47 and 48. No ultrasonic indications were found after testing. Damage at the leading edge is negligible, even though the high-speed movies show that impacts did occur at this location. However, the concave side sheath, aft of the leading edge, was nicked, gouged, and unbounded, as pictured in Figure 49. The gravel apparently strikes the sheath causing compressive stresses on the sheath exterior surface. The stress differential within the sheath is great enough to break the sheath-to-blade bond and then lift the sheath from the surface of the blade. Therefore it is concluded that with a better bond between sheath and blade, the leading edge sheath could offer satisfactory protection from small amounts of gravel ingestion.

Figure 47 Visual Damage to Boron/Epoxy Blade B-4 Following Impact with Gravel

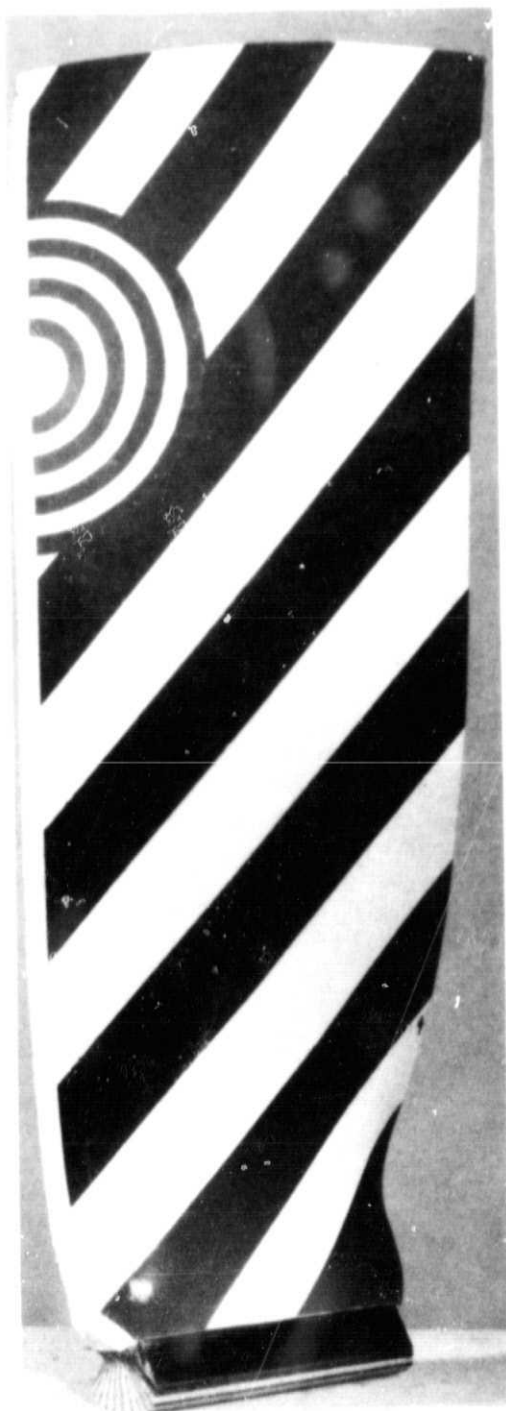
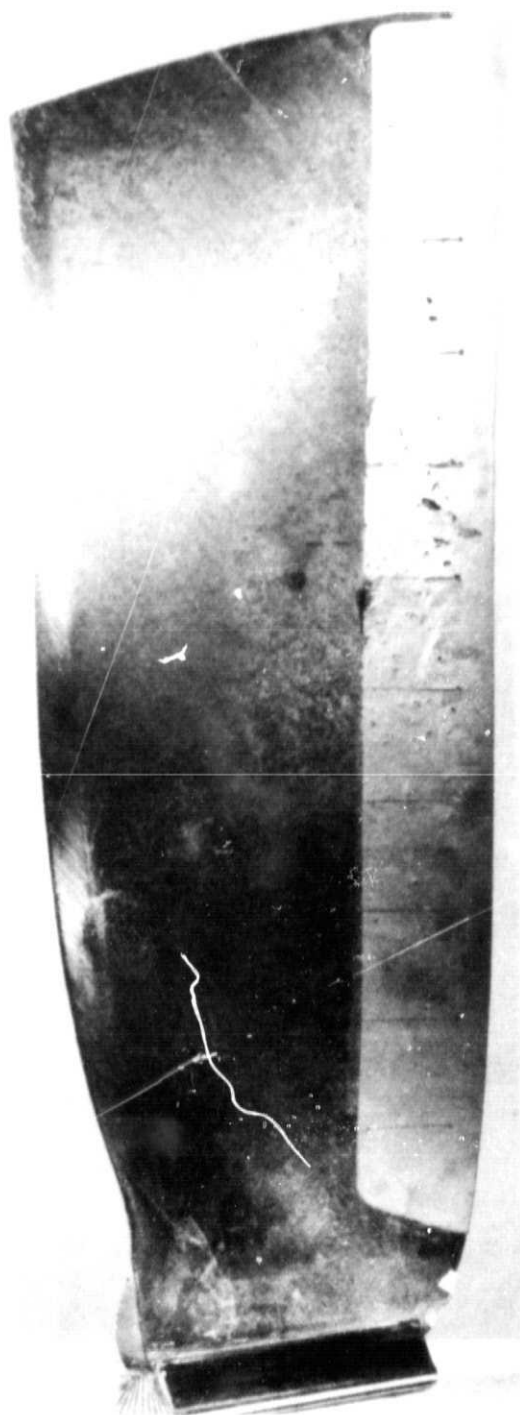
Figure 48 Boron/Epoxy Blade B-4 Following Impact with Gravel

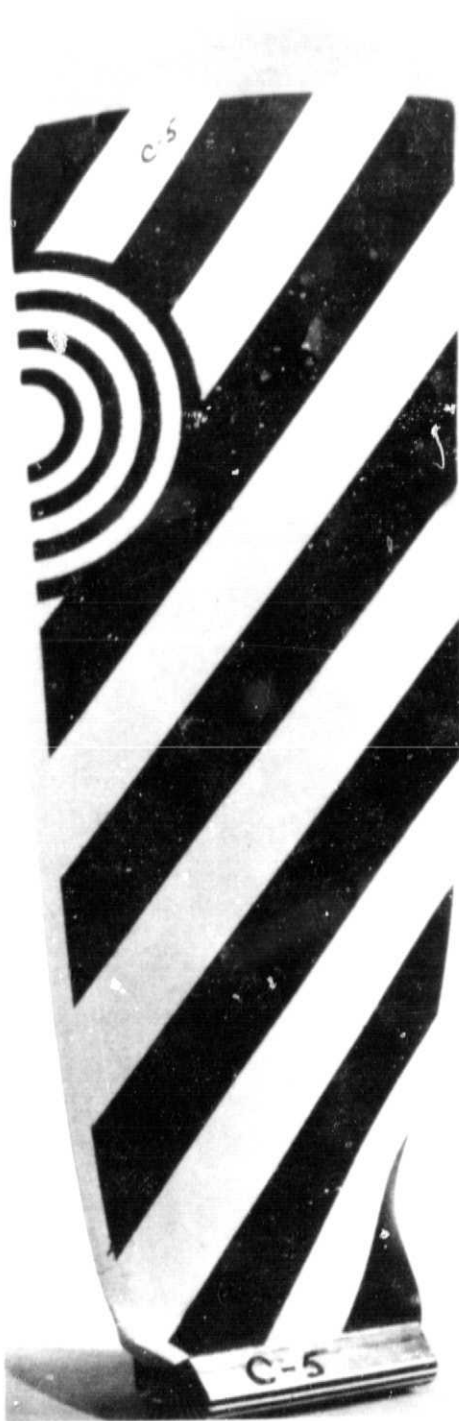
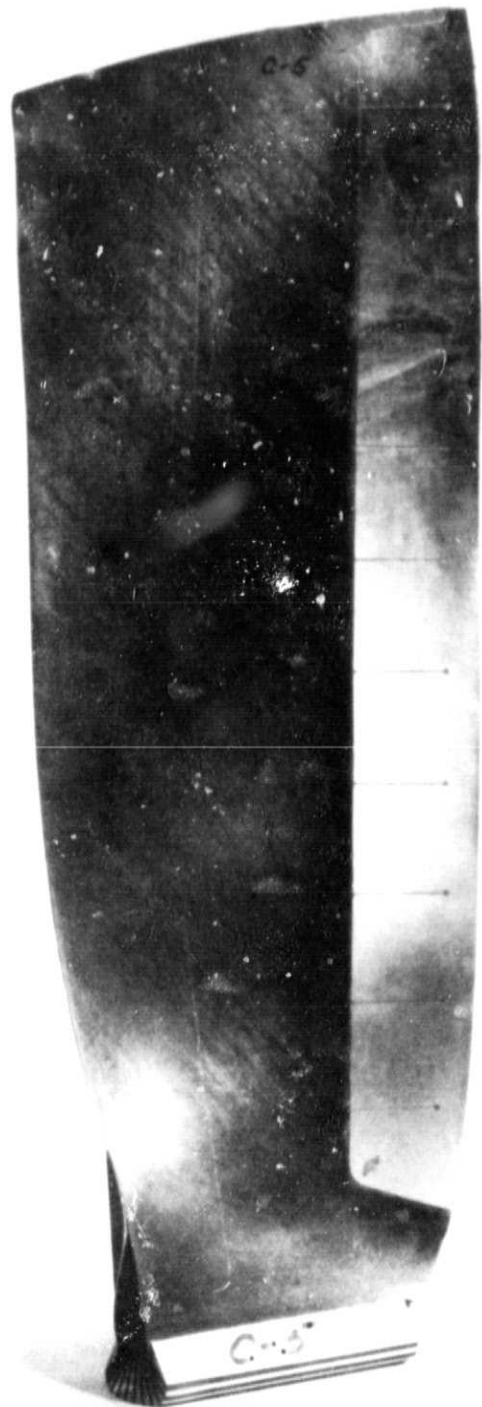
Blade C-5 and B-5 were impacted with 75g (2.6 oz) and 80 g (2.9 oz) starlings, respectively. The 40g (1.4 oz) slice taken by C-5 and the 45g (1.6 oz) slice cut by B-5 caused only slight damage in each case. The damage which occurred seems to be related to blade fabrication problems. Both blades are pictured in Figures 50 and 51 respectively.

Figure 50 Graphite/Epoxy Blade C-5 Following Impact with 75g Starling
